DEATH IN THE ICE-HOUSE

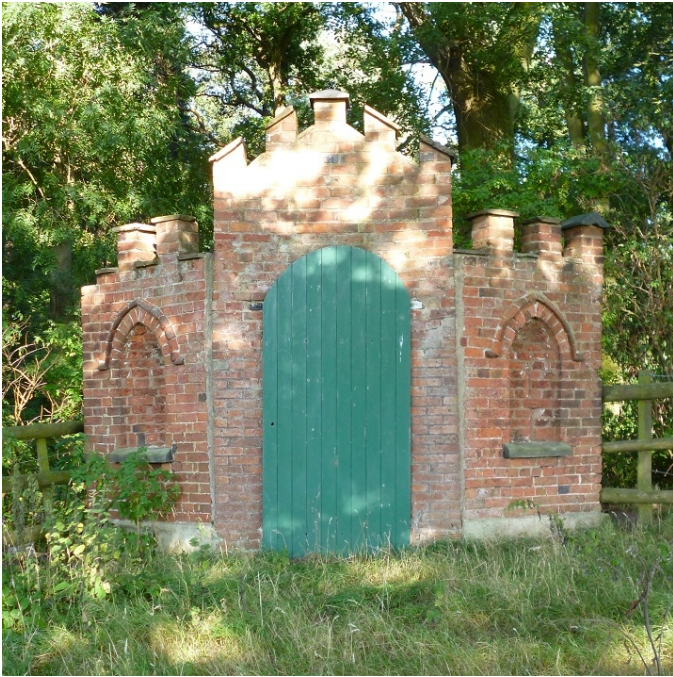
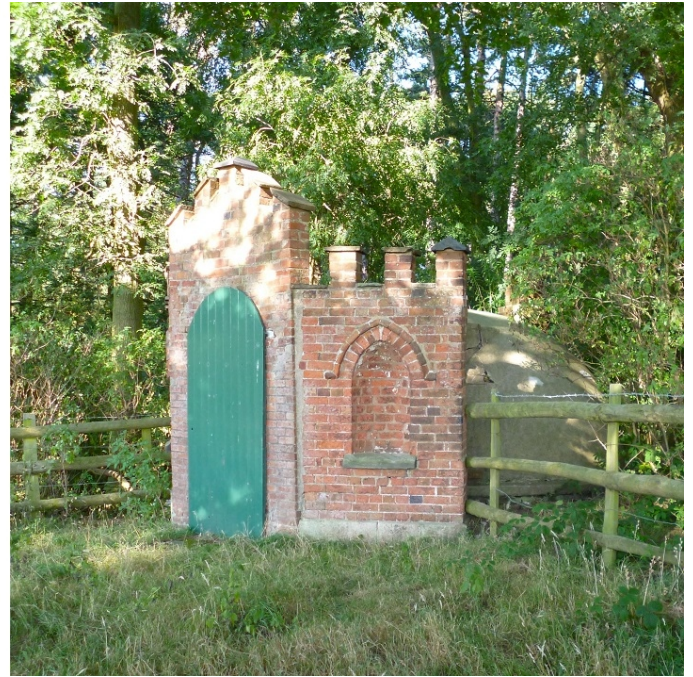
Two views of the ice-house at Locko Park taken in August 2015. Note the exposed and rendered dome of the ice-well visible in the second picture. © Peter Cholerton, 2025

Ice-houses were frequently situated some distance away from the properties they served, so as not to spoil the picturesque setting of the big house. Sometimes they were given a decorative entrance-facade, like the Grade II listed example embellished with castellations at nearby Locko, where the ice-house is approximately 200 yds east of the Hall on rising ground at the edge of a small wooded plantation.
