## WINDING THE CHURCH CLOCK

*First written in 2016, this article has now been updated and some new photographs added*

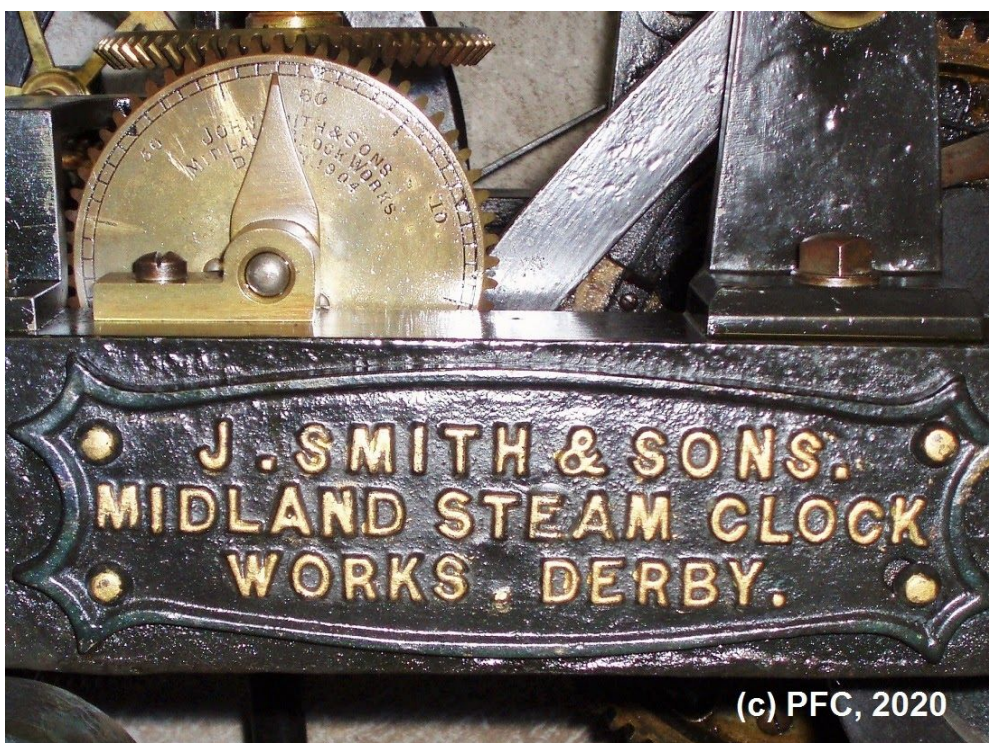
**Fig. 1: St. Mary's Church, Chaddesden ~ Clock name-plate and setting dial**

The clock keeps excellent time and typically only loses approximately 30 seconds or so a week under ordinary weather conditions. Fine adjustments to the time are made by two methods: if the clock is slow, the setting dial can be rotated forwards clockwise to the appropriate minute; however, if the clock is running fast, the mechanism cannot be moved backwards, so it is then necessary to halt the movement of the pendulum for the desired period of time. Unlike a conventional clock-face, the setting dial does not have any moving hands, just a single pointer for the minutes (Fig. 1), and so this

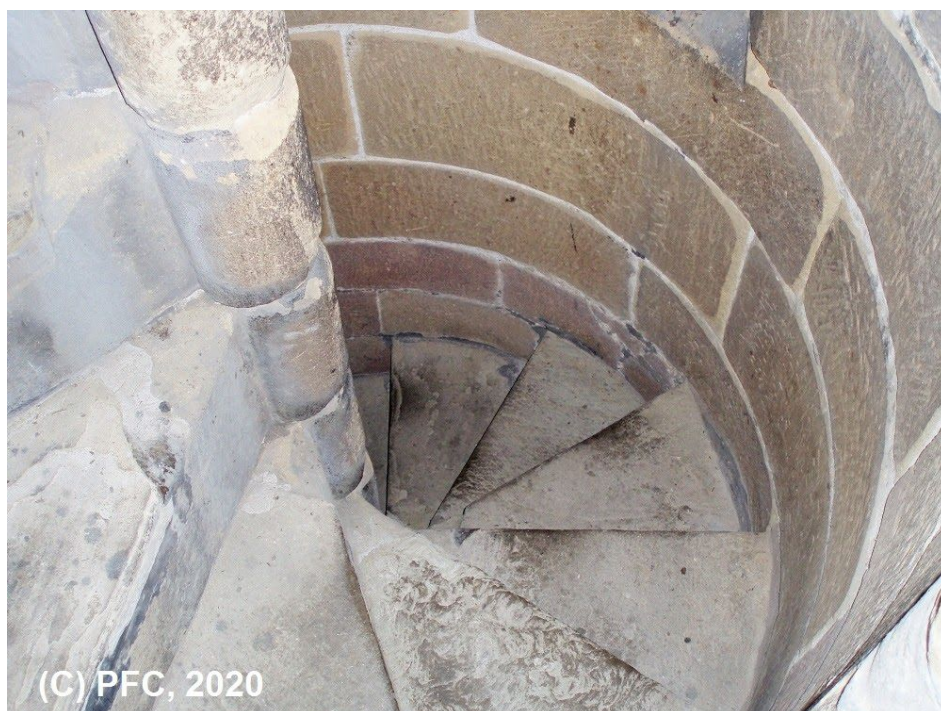
**Fig. 3: Looking down the spiral staircase**

Technically speaking, the clock in St. Mary's church tower, with a movement separate from the dials, is usually described as a 'turret-clock' [Note 2]. My own involvement with the clock goes back to September 1979 when I was asked if I would be willing to take on the duty of winding it each week. I said 'yes', little thinking that I would still be winding it until July 2017 when I eventually relinquished the job! To get to the clock mechanism it is first necessary to climb the 39 narrow and somewhat uneven steps in the spiral staircase (Fig. 3) which provides access to the ringing chamber on the first floor of the tower. For many years the only light in the stairway was supplied by four tiny, narrow windows, but thankfully electric light was installed in 2007.

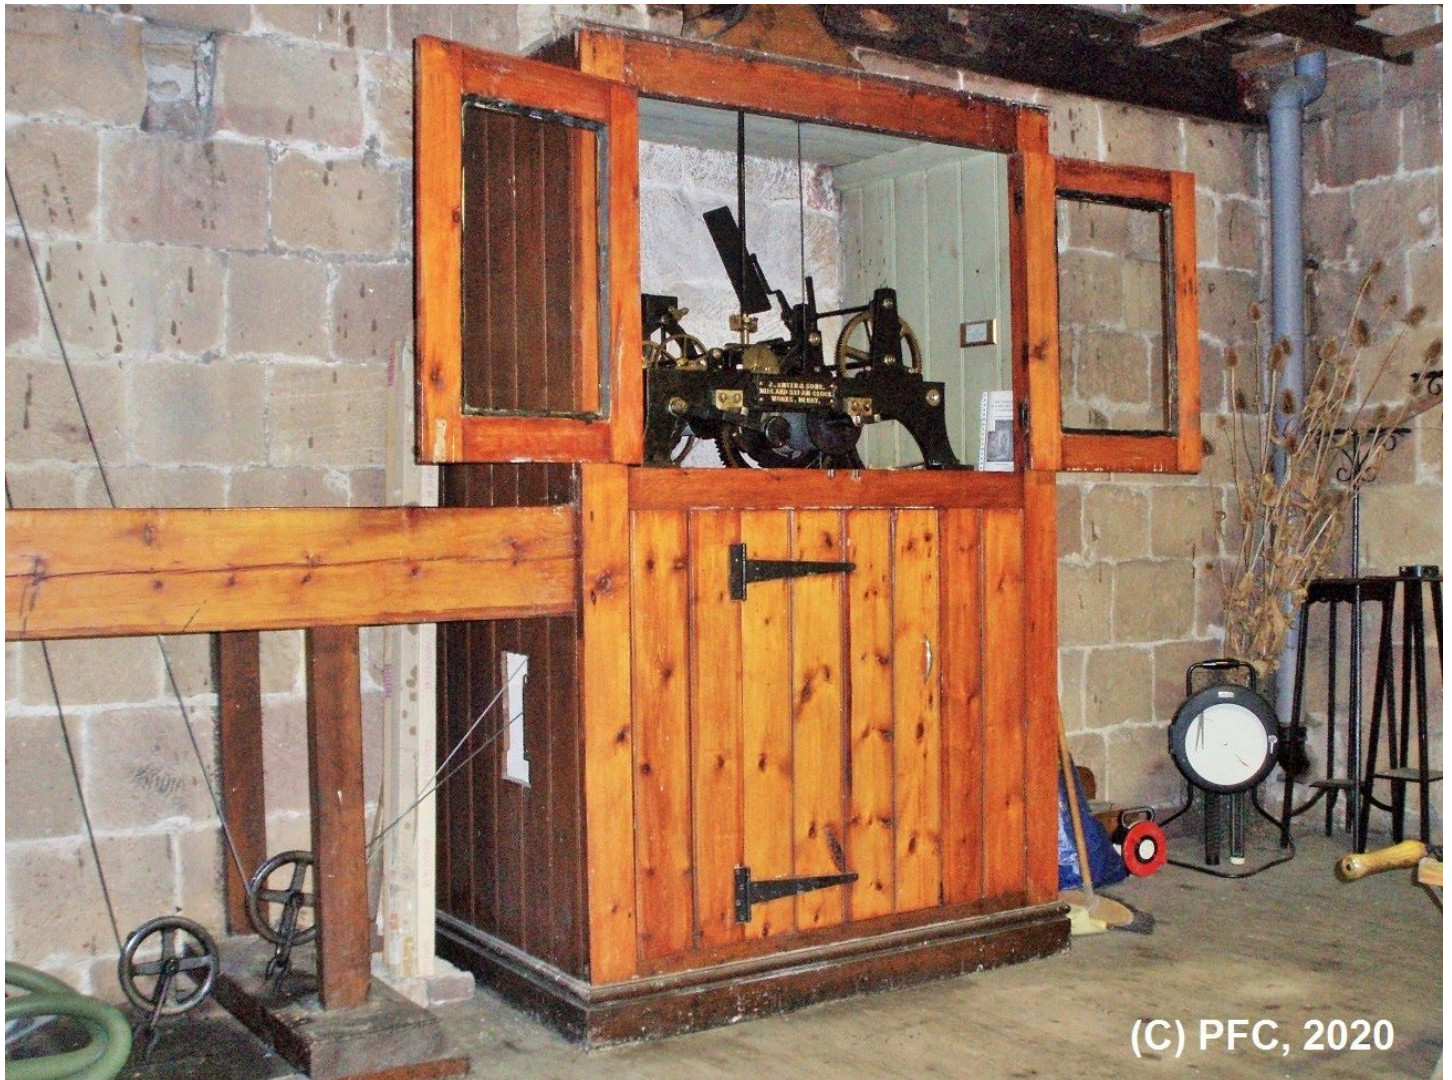
**Fig. 4: The large cabinet which protects the clock mechanism**

Once inside the ringing chamber, the clock mechanism can be seen over on the north wall, protected by a large cabinet of pitch pine some 7 feet tall (Fig. 4). A door at the bottom of the cabinet provides access to the pendulum.

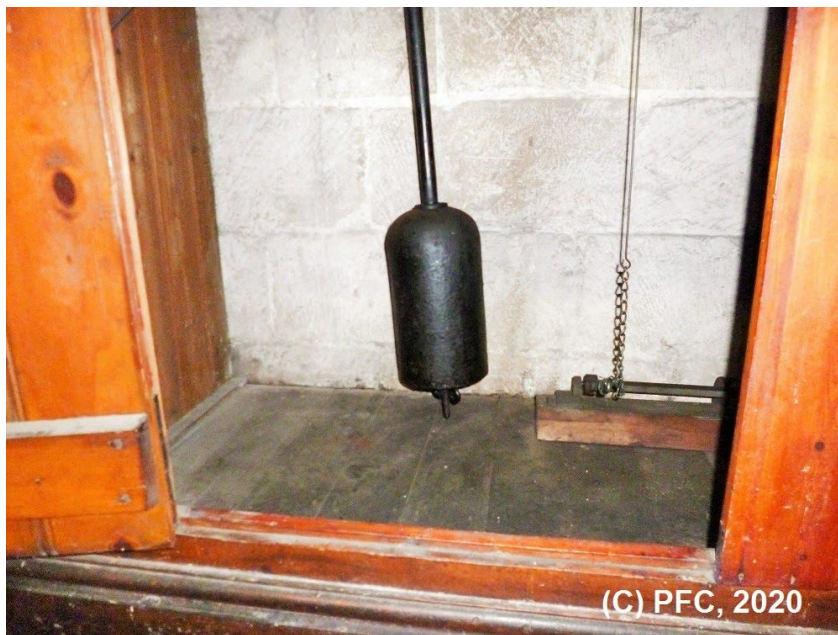
**Fig. 6: The pendulum 'bob'**

As Fig. 6 shows, the pendulum which is made of a long iron rod with a massive weight or 'bob' at the end can be seen by opening the bottom door in the clock cabinet.

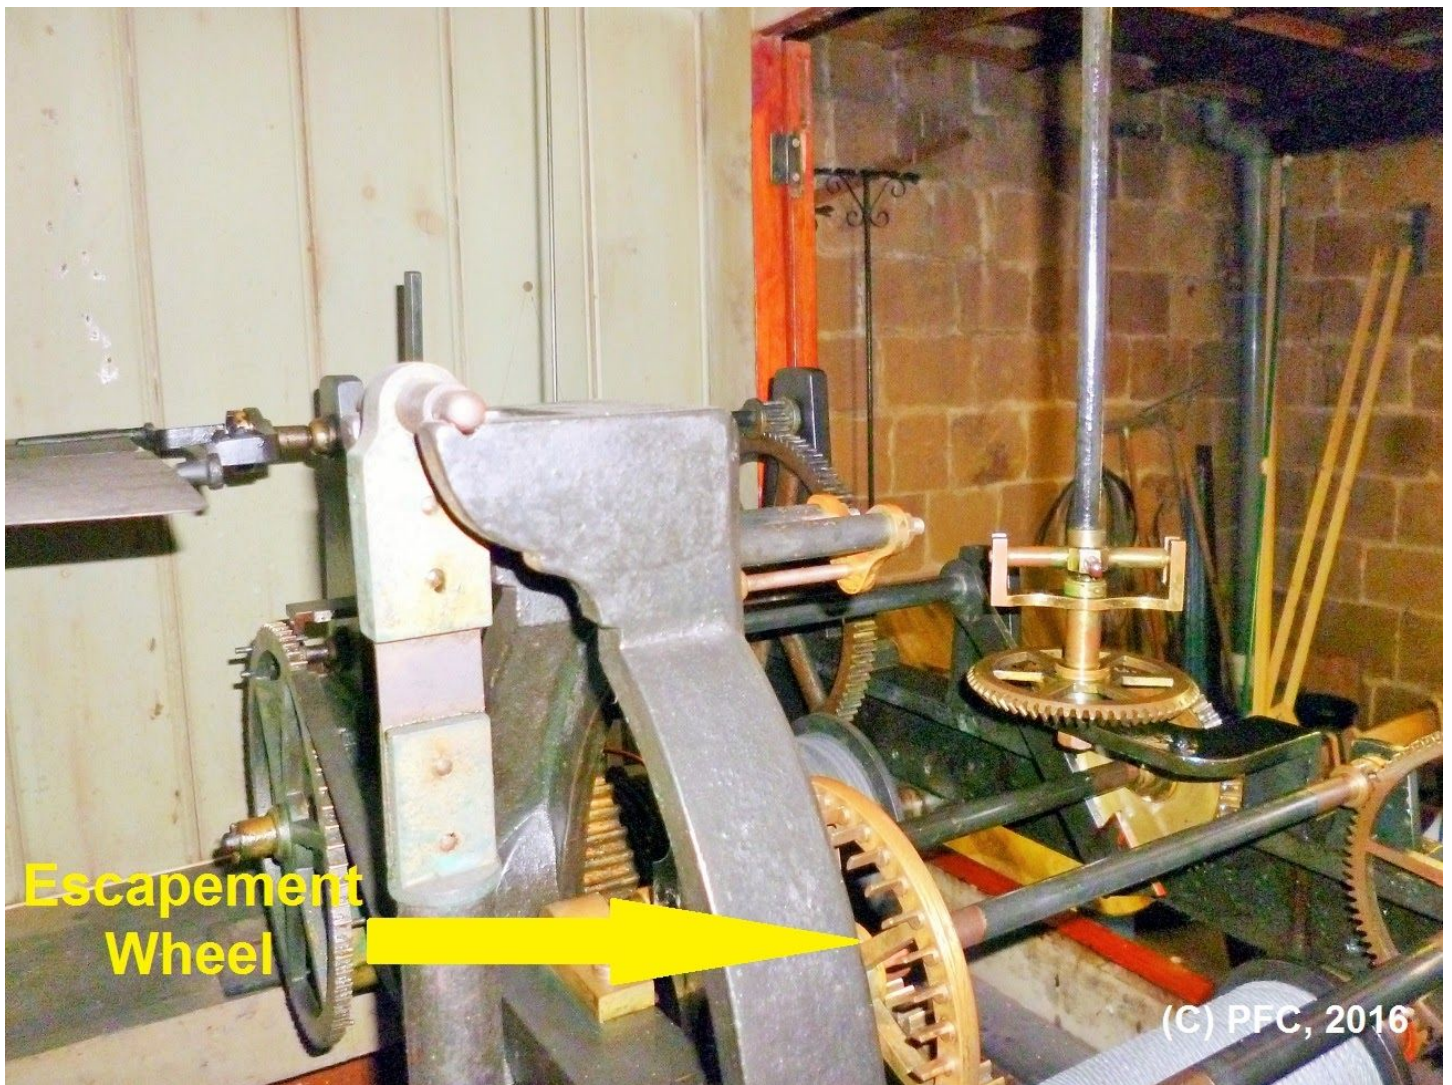
**Fig. 7: The escapement wheel as seen from the back of the clock cabinet**

Perhaps the most essential part of the going train is the escapement wheel (Figs. 2 & 7) which rotates once every 80 seconds and is linked to the pendulum by means of the escapement, an ingenious device which performs two vital tasks, firstly it permits one tooth of the wheel to move forward ('escape') every time the pendulum swings; this movement is then transmitted to the centre wheel which turns once every hour; secondly the escapement gives the pendulum a little nudge to keep it swinging, thereby giving rise to the familiar 'tick-tock' sound in the process.

From the centre wheel located just behind the setting dial (Figs. 2 & 7) the leading-off rod rises vertically up to the ceiling of the ringing chamber, from where two tracks of gears and rods provide the means by which the hands are moved on the clock dials situated on the west and south faces of the church tower.
