THE REMAINS OF AN OLD CORN-DRYING KILN IN WILMOT AVENUE

Possible remnant of corn-drying kiln, Wilmot Avenue, Chaddesden

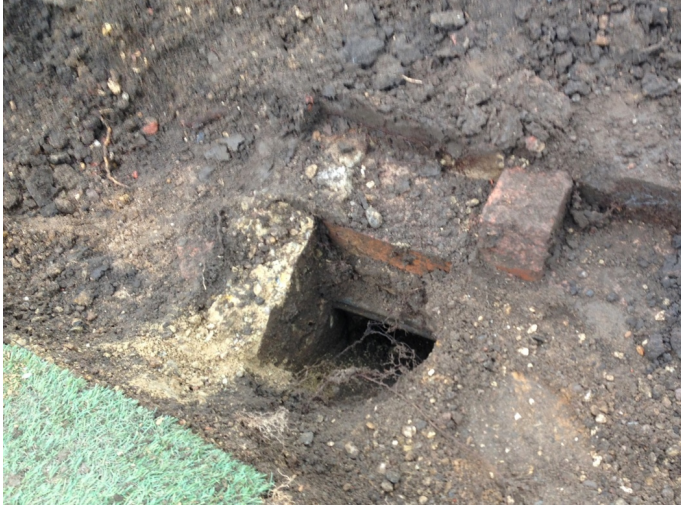
In January 2022, Ian Burton of 5 Wilmot Avenue,¹ was laying some paving slabs to make a path in his new greenhouse when he spotted a hole in the ground a few centimetres in diameter with what appeared to be a metal plate on top of it (Fig. 1)

Fig. 1: The hole in the ground makes its first appearance.

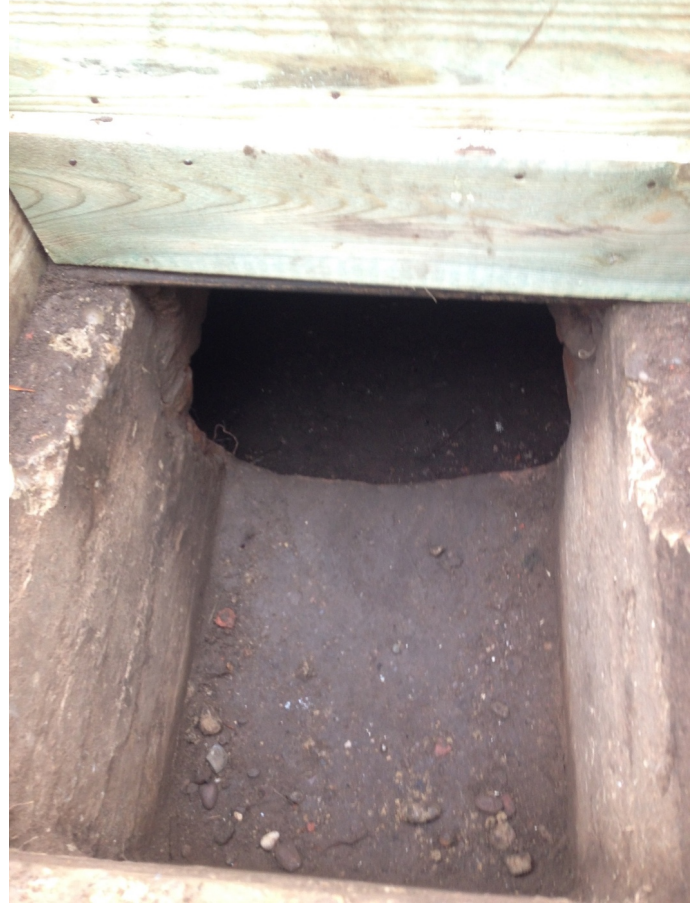
Curious to find out what this was, he removed more of the soil to reveal a small brick-lined cavity roughly 46cm x 48cm x 64cm deep (Fig. 2). This, however, was only the start of the puzzle, for at the back of the cavity lay a much larger void extending deeper underground. Ian then set about clearing this and after much hard work was finally able to squeeze himself into a strange and very confined subterranean chamber and take photographs of his discovery.

Fig. 2: This brick-lined cavity was revealed when the hole was cleared out. Note the start of the much larger void at the back.

(1) If the structure is the drying chamber of a kiln, how did its owners access it for periodic cleaning and maintenance purposes? Did they have to crawl through the small cavity shown in Figs 2 and 7, or was there another way in, as yet undiscovered?

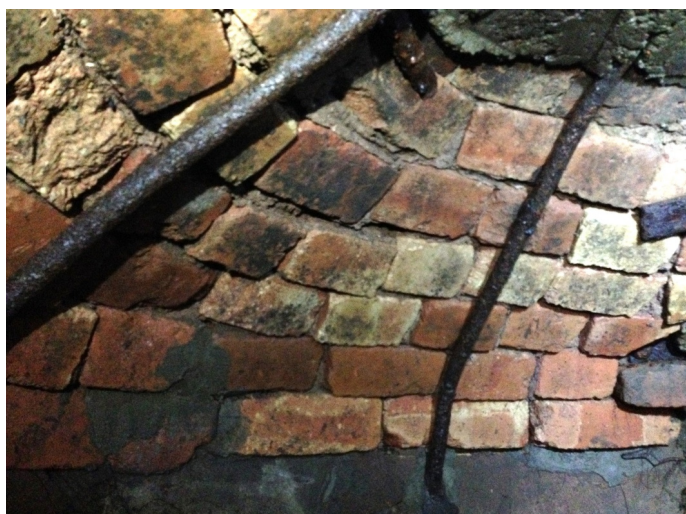
It now became apparent that buried underneath his garden was an odd-looking circular chamber, roughly 137cm in diameter and some 152cm in height; its topmost seven courses of hand-made bricks were supported by metal ribs and corbelled inwards so as to form a dome (Figs 3 and 4), at the apex of which was a concrete cap acting as the structure's roof (Fig. 4). Ian took his photographs along to the March 2022 meeting of Chaddesden Historical Group to see if anyone could identify this mysterious object.

Fig. 3: The chamber roof. Note how the topmost courses of bricks are corbelled inwards and the metal supporting ribs.

(5) How old is the underground chamber? Unfortunately there is little hard evidence for a date, other than the fact that the bricks visible in Figs 3 and 4 are hand-made. As noted earlier, the chamber – whatever its purpose – could well have functioned at any point in time between, say, the late Georgian and early Victorian periods, roughly 1780–1850. The earlier date would apply if the structure was as old as the barn, which is known to have been there in 1792

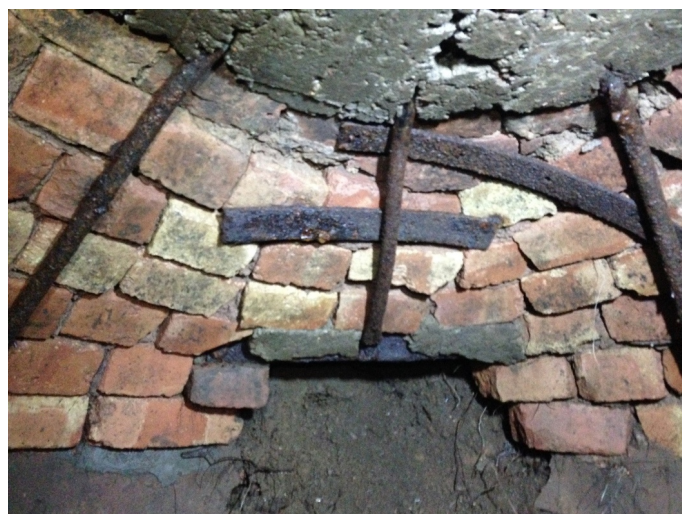
Fig. 4: This photograph was taken a little to the right of Fig. 3 and clearly shows the concrete roof cap as well as a recess in the wall of the chamber.

(2) If the concrete cap of the underground chamber is an original feature, it would of course have completely prevented warm air from rising to dry the grain on the floor in the barn above and thus defeated the purpose of a drying chamber. However, the cap could equally well have been placed there at a later stage in history in order to repurpose the chamber for another function when the kiln ceased to be used. Alternatively, maybe the small cavity shown in Figs 2 and 7 was intended to direct the heat upwards to the grain drying floor above. It has also been suggested that the brick courses forming the dome of the chamber roof were probably self-supporting and that the metal ribs visible in Figs 3 and 4 could well have been supports for a chimney of some sort that was later demolished and replaced by the concrete cap, which does not seem to be bonded into the adjacent brickwork and must therefore be of a later date.¹⁰

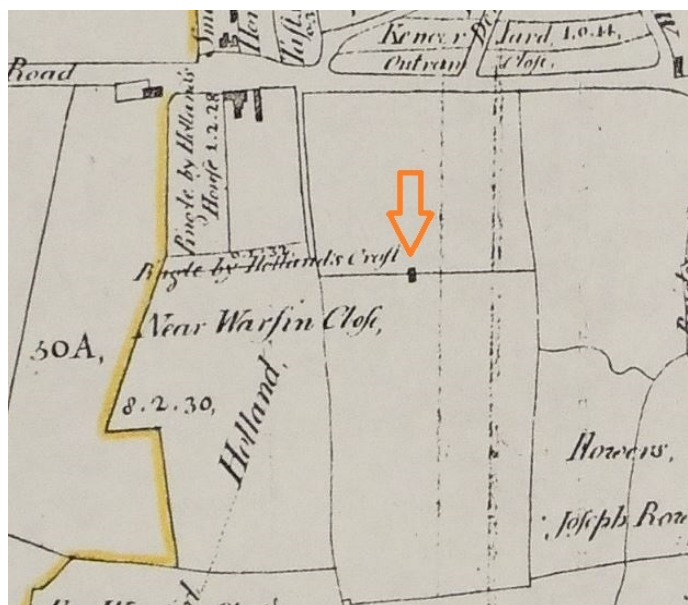
Scaled measurements taken from old Ordnance Survey maps showed that the barn was a comparatively small one (probably of three bays) measuring approximately 4m x 9m and oriented roughly north–south. It was certainly of some antiquity since it is featured on the Chaddesden enclosure map of 1792 (Fig. 5) where it sat astride a field boundary, however, by the time the first large scale Ordnance Survey map was published in 1883 (Fig. 6) this field boundary had vanished.

Fig. 5: Chaddesden enclosure map of 1792 showing the barn. Nottingham Road runs across the top of the map from left to right.

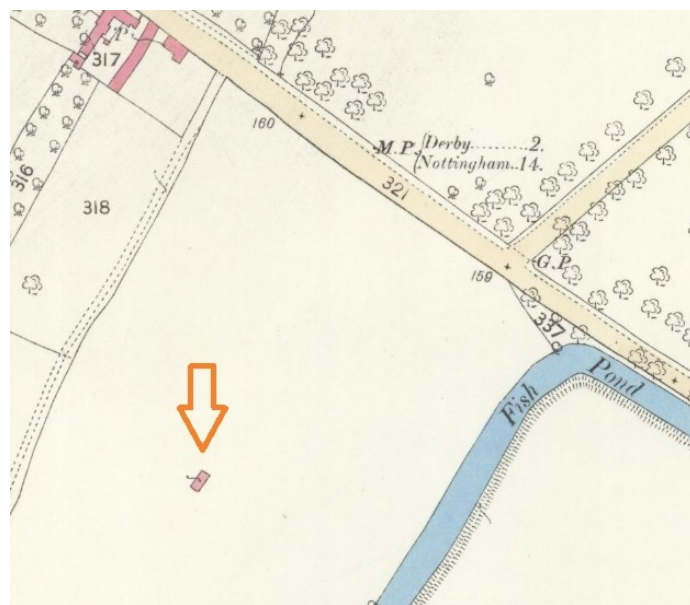
Fig. 6: The barn is shown again, this time on the Ordnance Survey map of 1883.

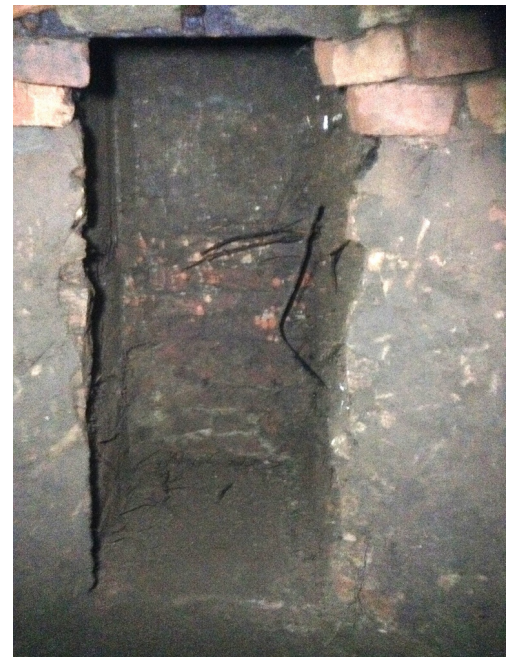
In the months after his initial discovery, Ian was able to dig out more of the structure and discovered it had a concrete floor. He also managed to investigate what was previously thought to have been the opening to a length of flue in its south face, which turned out to be a recess more closely resembling a small fire-hole or similar (Fig. 8).

Fig. 8: The recess in Fig. 4 was excavated to reveal this.

(4) If this is indeed a drying chamber then did it function with, or without, a flue? Might the recess shown in Fig. 8 be part of a flue assembly?
